Intel[®] Pentium[®] III Xeon[™] Processor Specification Update

Release Date: March 2000

Order Number: 244460-012

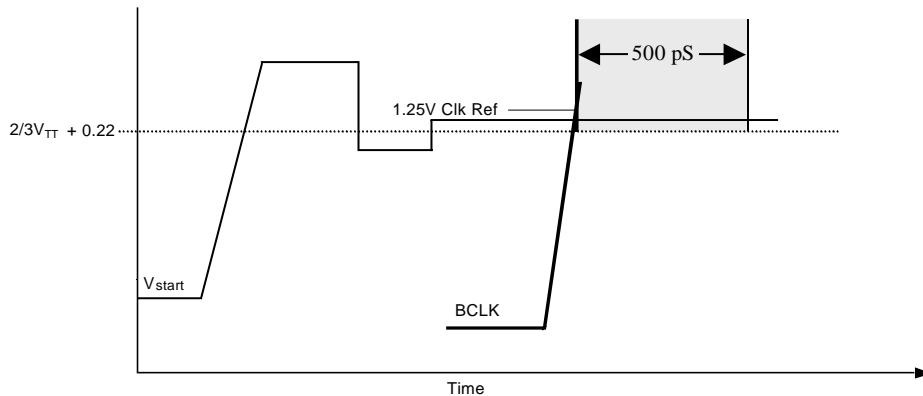
The published AGTL+ AC specification for $V_{IH(MIN)}$ is $(2/3 \cdot V_{TT}) + 0.1$ Volts.

Intel has characterized the new AGTL+ AC specification for $V_{IH(MIN)}$ on the processor's RS0# signal to be: $(2/3 \cdot V_{TT}) + 0.22$ Volts within 500 picoseconds following the rising edge of BCLK crossing the 1.25-Volt threshold. See below.

Implication: The deviation from the published specification results in decreased noise margin on the RS0# processor input. This decreased noise margin has been observed to be particularly detrimental in system environments where the RS0# processor input is being driven by an I/O buffer with a pull-up device (such as a p-channel transistor) that is switched off mid-cycle. Systems that employ I/O buffers that keep the pull-up device on for the entire cycle are significantly less affected by this erratum. The reduction in noise margin may lead to the generation of BINIT# (when enabled) resulting in a system reset, otherwise this condition may lead to a system "hang" condition.

Workaround: If a system design cannot meet the specification deviation, the following areas should be carefully examined to assure that additional margin exists in order to compensate for any deficit observed with respect to the newly characterized $V_{IH(MIN)}$ specification:
